Chapparal

Bolt Failure on a Racing Automobile

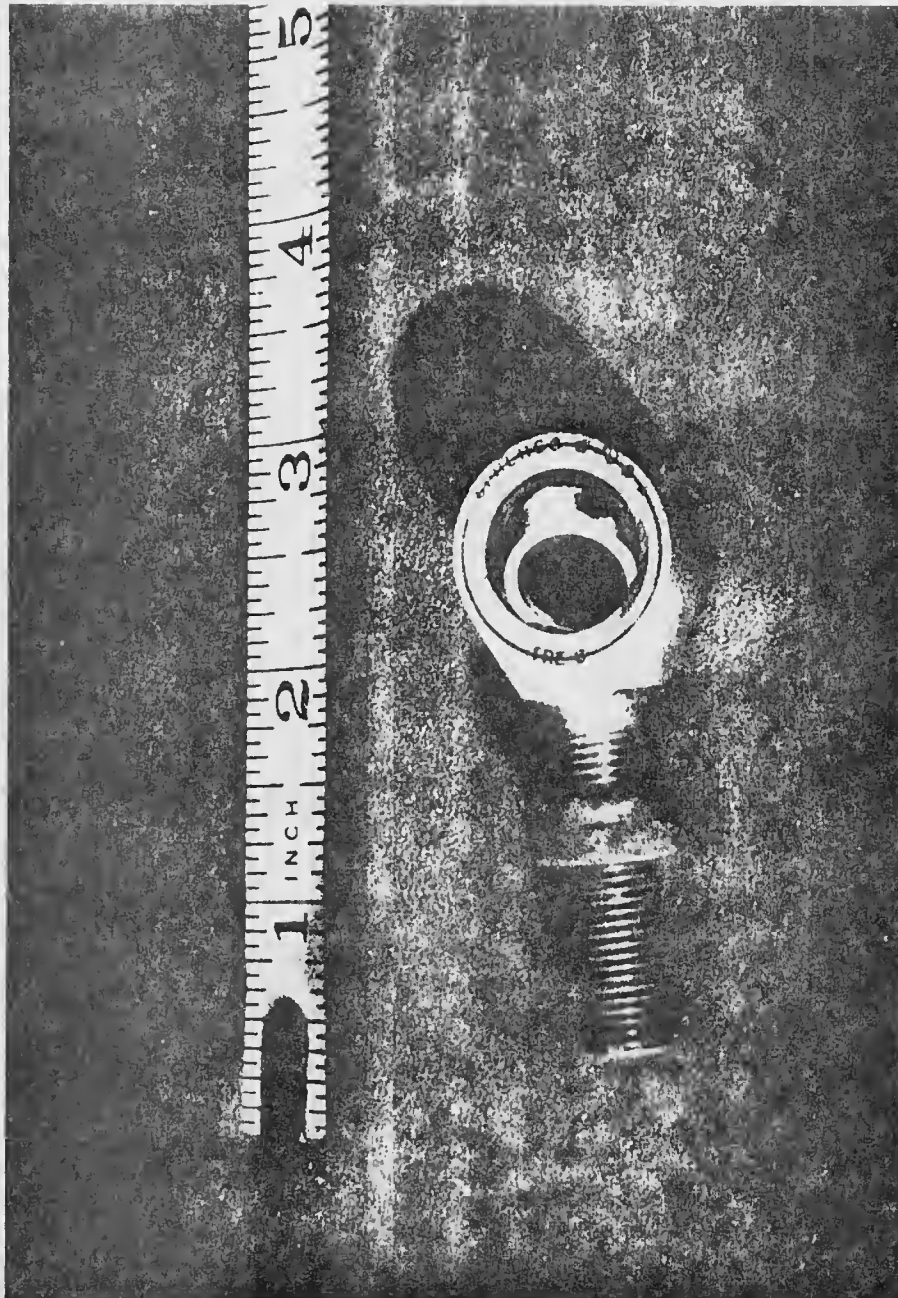
Mr. Hall pointed out to those at the meeting that the failure the press referred to on each of his cars was not a bolt failure, but was a fracture of the rod end where the stabilizing link shown in Exhibits 2a and 2b is joined to one end of a ball joint which, in turn, is joined to the wing strut. What actually happened was that these rod ends broke and the strut fell against the rear wheel causing the reported blowouts. The stabilizing link was connected to the wing strut by a ball and socket joint, one end of the joint being rigidly attached to the link. The joint was screwed into the link and held in place by means of a lock nut. The fracture, which appeared to be a fatigue failure, was located on the threaded shaft of the joint where the lock nut adjoined the stabilizing link. Mr. Hall assumed in the initial design of the strut assembly that the main force acting on the link would not exceed that caused by a lateral acceleration of one "g". The links that broke should have withstood this force.

Exhibit 2b. Ball joint of the type that failed on the Chaparral stabilizing link.

Mr. Hall's solution to the problem was to: 1) straighten out the stabilizing link in order to eliminate the bending moment at the threaded rod; and 2) redesign the joint so that it would be capable of withstanding three times the original design load. To accomplish this modification, however, Mr. Hall had to flatten the left exhaust duct on his cars.

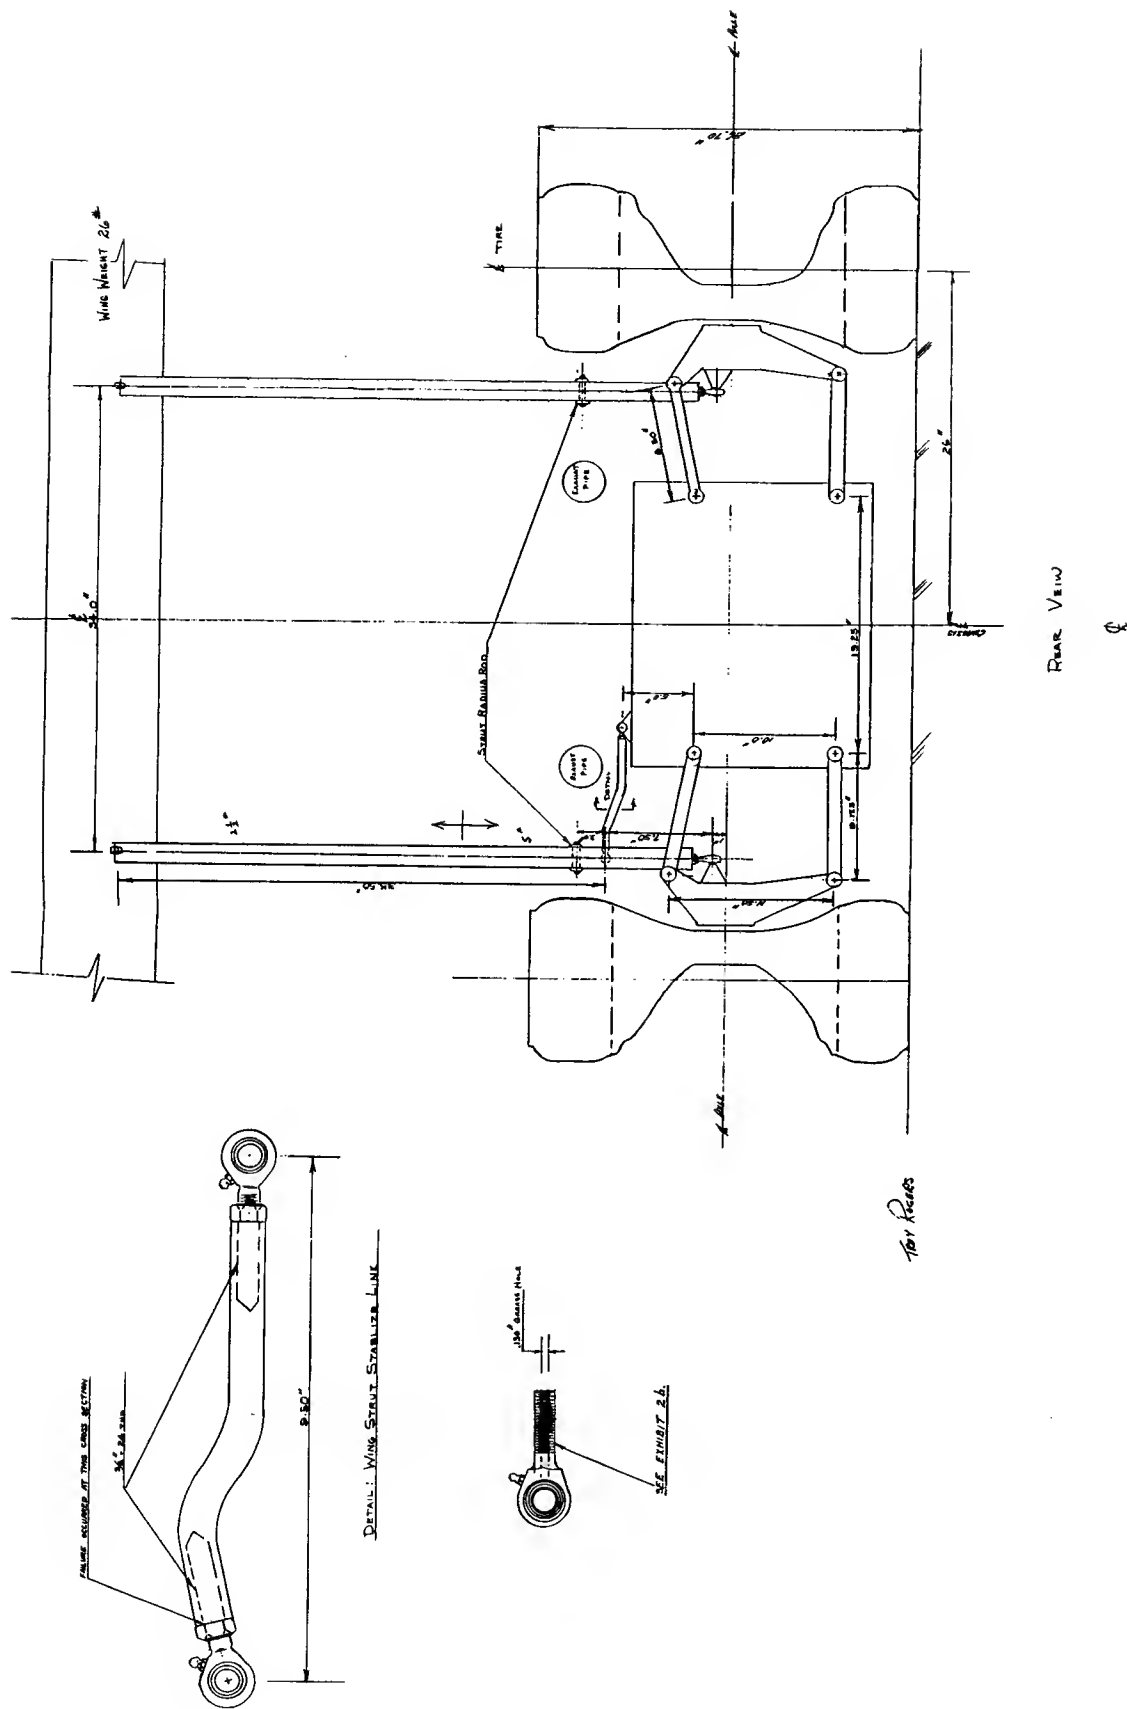
For lateral support of the wing assembly, Mr. Hall had provided a stabilizing side link attaching the left wing strut to a rear chassis bulkhead. Because he wanted to avoid disturbing the exhaust duct on that side of the car, Mr. Hall put a bend, as shown in Exhibit 2, in the stabilizing link so that it would miss the duct.

Exhibit 2a. Chaparral wing support diagram.
